S&W SUPPLY COMPANY, INC.

INDEX PAD HEIGHT ADJUSTMENT

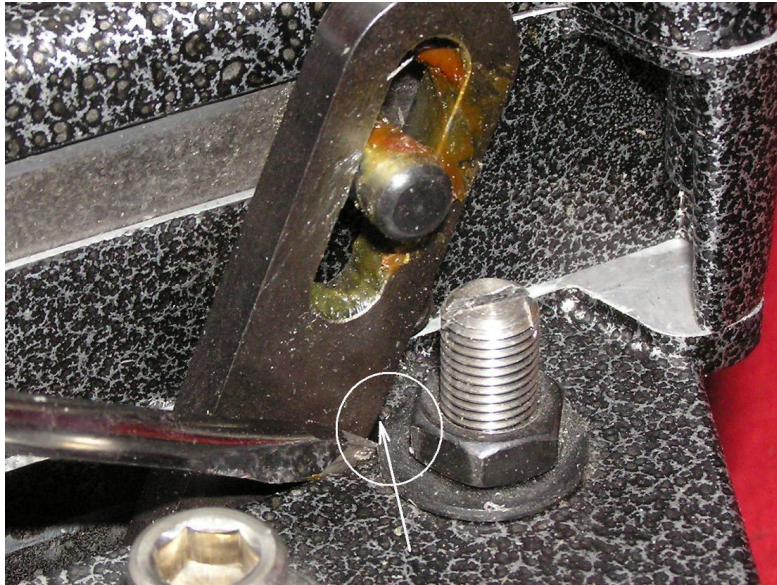
Figure 1

- With Crosshead in full-down position (Handle in HOME position), the Link called the Upper Actuating Arm (800 Plus #50, 800B #88 – See Figure #1) must gently rest on the rear portion of the aluminum Shot/Powder Reservoir, NEVER tightly, and preferably with a 1/8"-1/4" gap. Too far forward will cause Shot/Powder plastic gears to be out of time, and too far back with the Link continually hitting the rear opening will eventually break the Link.

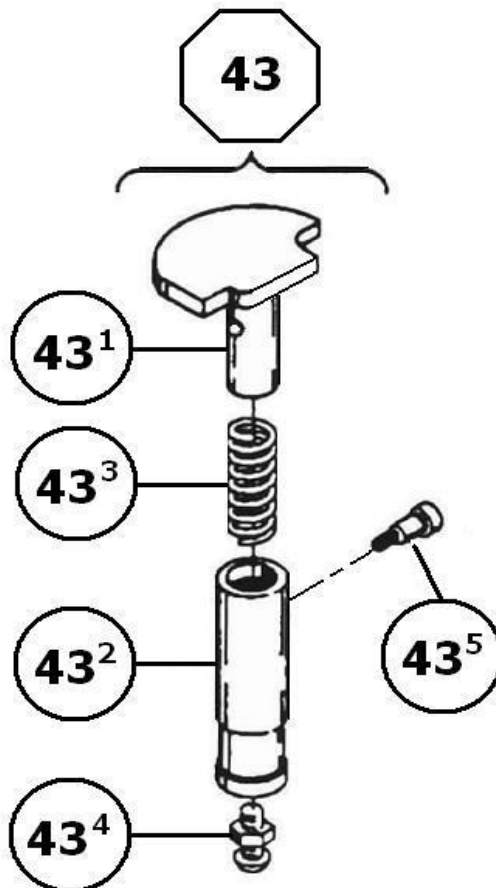
Figure 2

4. CORRECT HEIGHT ADJUSTMENT is set by turning in/out the adjusting screw (See Figure #2, part 43⁴) on the bottom of the Index Pad. Correct height is maintained by the following conditions:

INDEX PAD

800B/C/CVT & 800 PLUS MACHINES ONLY
